RESIDENTIAL INSPECTION

1234 Main Street Washington, KS 66968

> Buyer Name 09/05/2022 9:00AM

Inspector Christian Hanekom InterNACHI Certified home inspector 7857477806 hanekomcollc@gmail.com

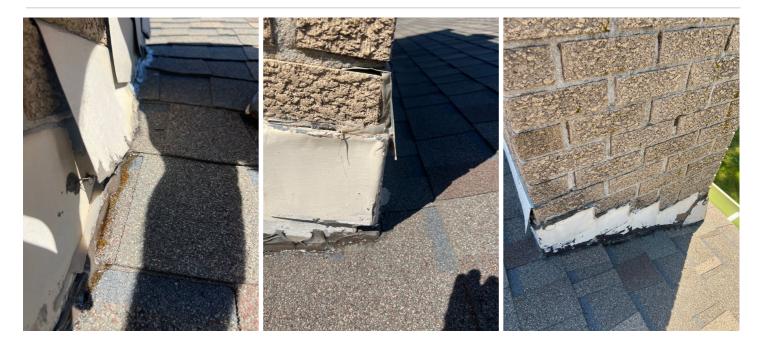
3.8.1 Asphalt Shingles

DAMAGE: WORKMEN, MINOR

Minor damage to the asphalt shingle roof appeared to be the result of careless workmen. It will not affect the ability of the shingles to perform as designed or affect their lifespan.

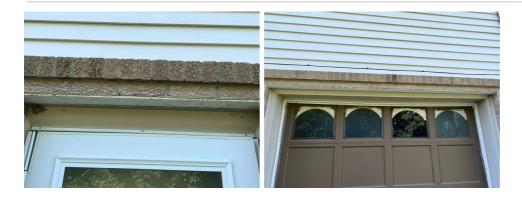
4.3.2 Door/Window Exteriors

DOORS: SEALANT NEEDS MAINTENANCE- QC

Sealant around door exteriors was old, discolored, cracked, and needed maintenance to avoid potential moisture intrusion. Work should be performed by a qualified contractor.

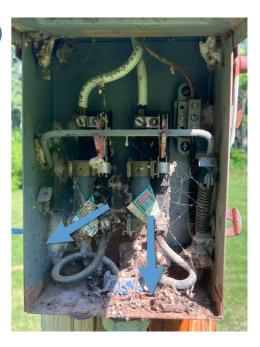
Interior components of the electrical service panel exhibited minor amounts of corrosion indicating moisture intrusion. Corrosion can degrade electrical contacts with the potential to cause problems related to component overheating. If it continues over time, this condition could become a potential fire hazard. The inspector observed no obvious points of moisture intrusion.

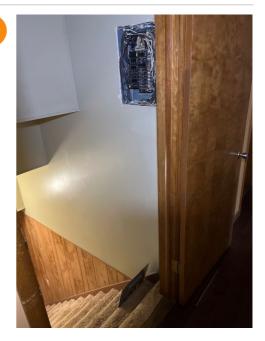
7.7.4 Main pannel

INTERIOR: CORROSION- QC

Contact a qualified electrical contractor.

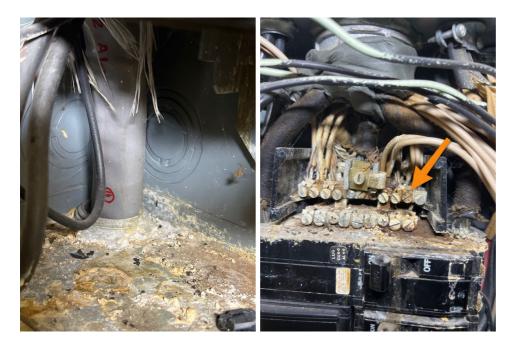
7.7.5 Main pannel INTERIOR: PAINT OVERSPRAY- QC

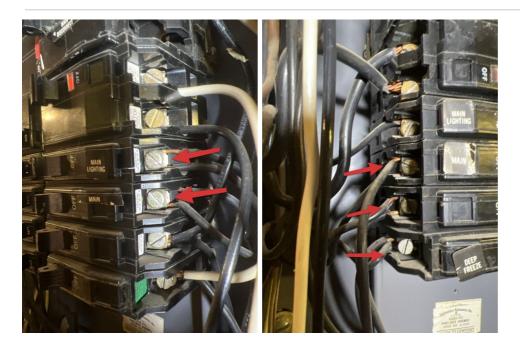
7.8.4 Sub-Panel

OCPD: NO GFCI- INSTALL GFCI BREAKERS

Contact a qualified electrical contractor.

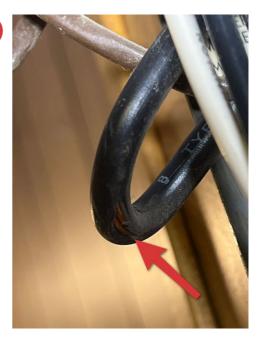
7.8.6 Sub-Panel

WIRING: TERMINATION IMPROPER - QC

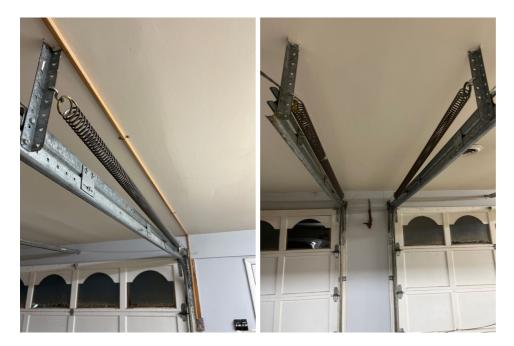
8.1.3 Overhead Doors ENDS OF USEFUL LIVES- QC

Serious Concern/Action Needed

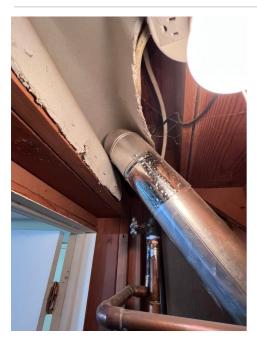
10.3.2 Water Heater

GAS WATER HEATER: FUEL SUPPLY, NO DRIP LEG- QC

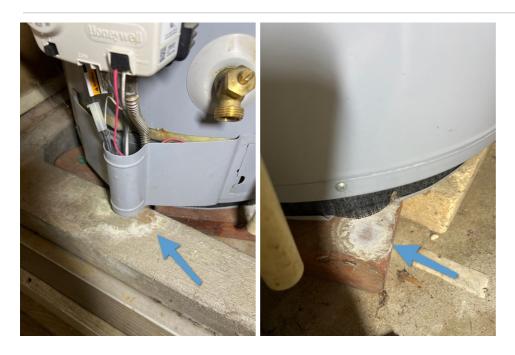
10.3.4 Water Heater **WATER HEATER PAST DESIGN LIFE**
