RESIDENTIAL INSPECTION

1234 Main Street Washington, KS 66968

> Buyer Name 09/05/2022 9:00AM

Inspector Christian Hanekom InterNACHI Certified home inspector 7857477806 hanekomcollc@gmail.com

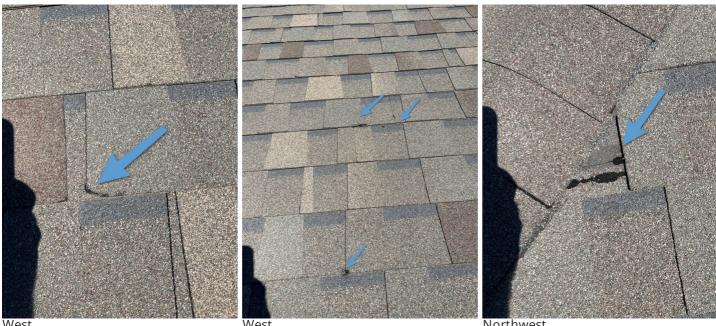
DAMAGE: WORKMEN, MINOR

Minor damage to the asphalt shingle roof appeared to be the result of careless workmen. It will not affect the ability of the shingles to perform as designed or affect their lifespan.

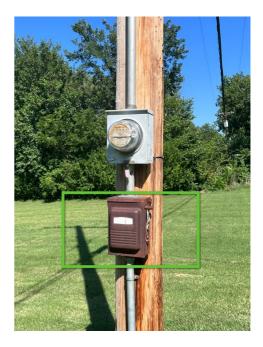
MANUFACTURER: UNABLE TO DETERMINE

The Inspector was unable to determine the service panel manufacturer due to missing information.

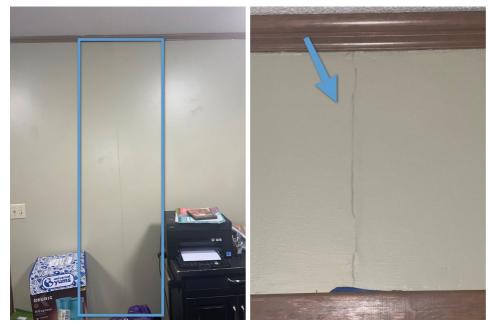
DRYWALL, POOR INSTALLATION

Drywall in the kitchen exhibited evidence of poor installation practices.
